Manhole Inspection Summary

Manhole # S09WW1005MH

Insp Date: **8/1/06 8:40 AM**

Location Address: **2608 KEN OAK RD**

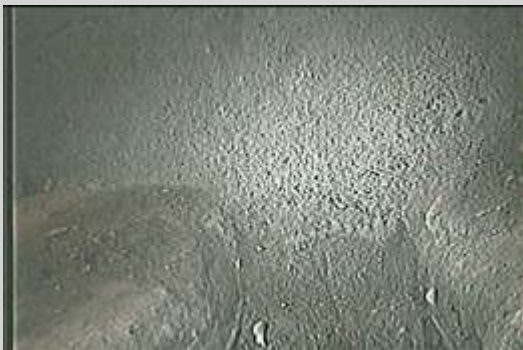
Pipe In @ 9 O'Clock

Pipe Material: ☐ Pipe Lined

Invert Depth: (ft.) Flow Characteristics: **None**

Infiltration: **None** Pipe Seal Cond: **Unknown**
